NRF WEEKLY TECHNICAL POST

NRF INTRODUCES AWP – AUXILIARY WATER PUMPS >

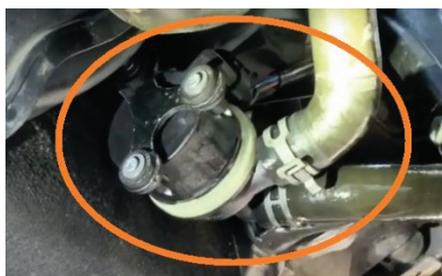
Many modern cars with charged combustion engines require continuous cooling during a stop (#Start/Stop system), or after turning off the engine (2-3 minutes). The AWP secures after-cooling of the cylinder head and/or the liquid-cooled turbocharger (#Turbo). On EV and Hybrid cars it secures the constant temperature of the batteries and cooling the inverter (#Hybrids).
